# Maple Valley - Legacy Site

## Comparative Analysis and Tree Survey

# Legacy Site Tree Survey: 11/10/2017 & 11/18/2017

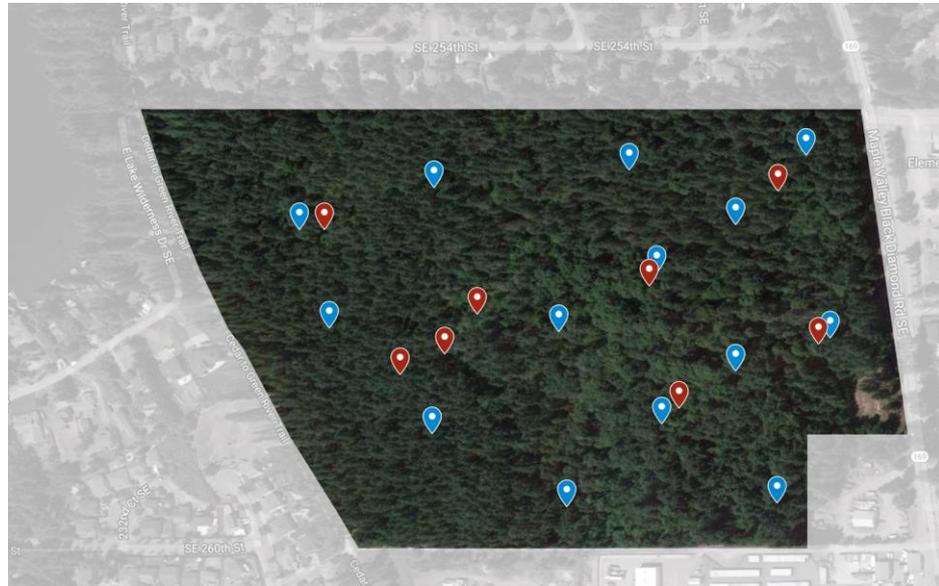
Collaborating with students from the School of Environmental and Forest Sciences, 14, 1/20th acre plots were surveyed throughout the Legacy Site. Using state of the art technology to record tree height, circumference, and location, we were then able to extract useful information applicable to future development research.

## Tree Measures:

- Species
- Height
- Circumference
- Location
- Surrounding Features

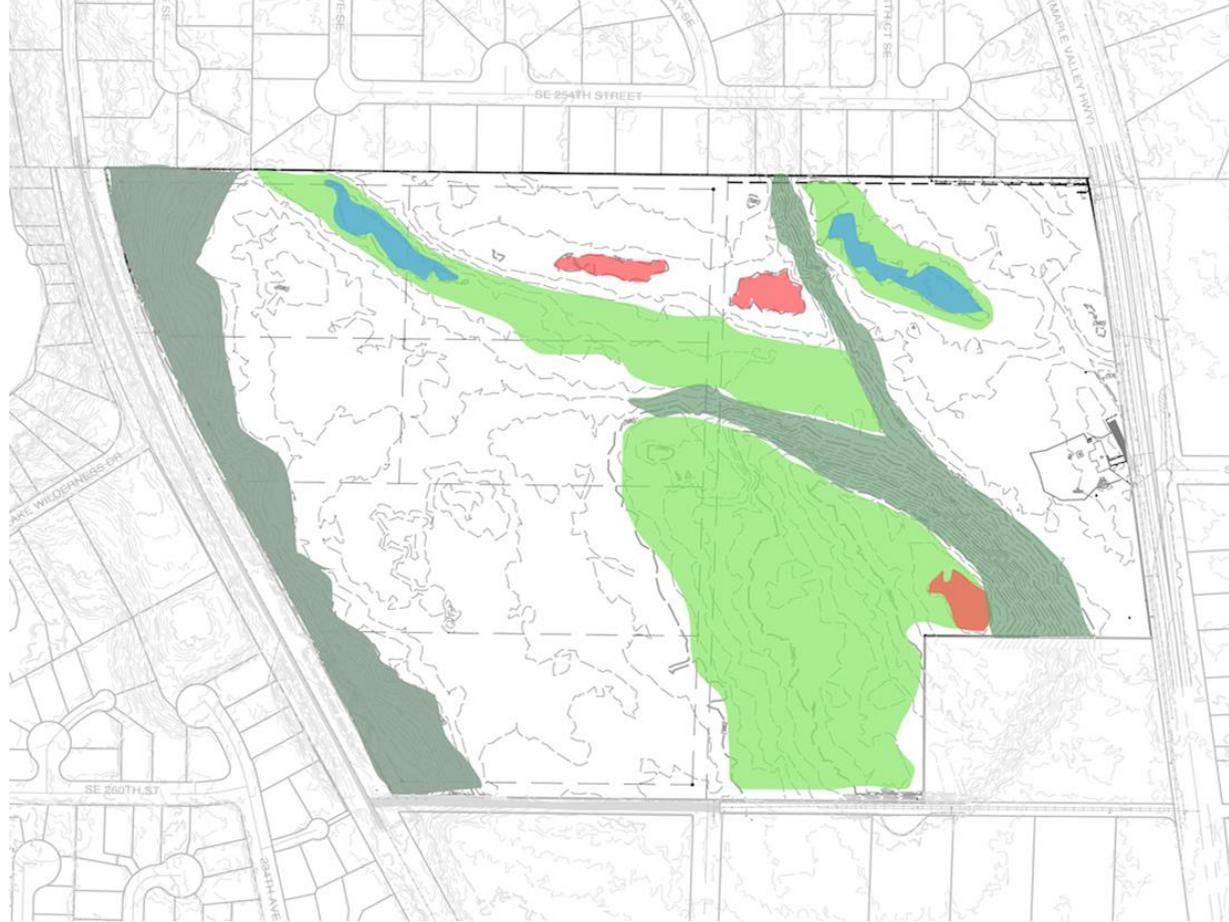
# Topographic Map

Walking through the Legacy Site provides a first hand look of this diverse terrain. A network of pathways allow pedestrians to wander up hills, through plateaus, and around local habitats.

### Forested Swales:

Shallow, low-lying and intermittent drainage ways.

### Forested Steep Slopes:

Moderate and typically steep slopes (10% or greater)

Local High Point

Local Low Point

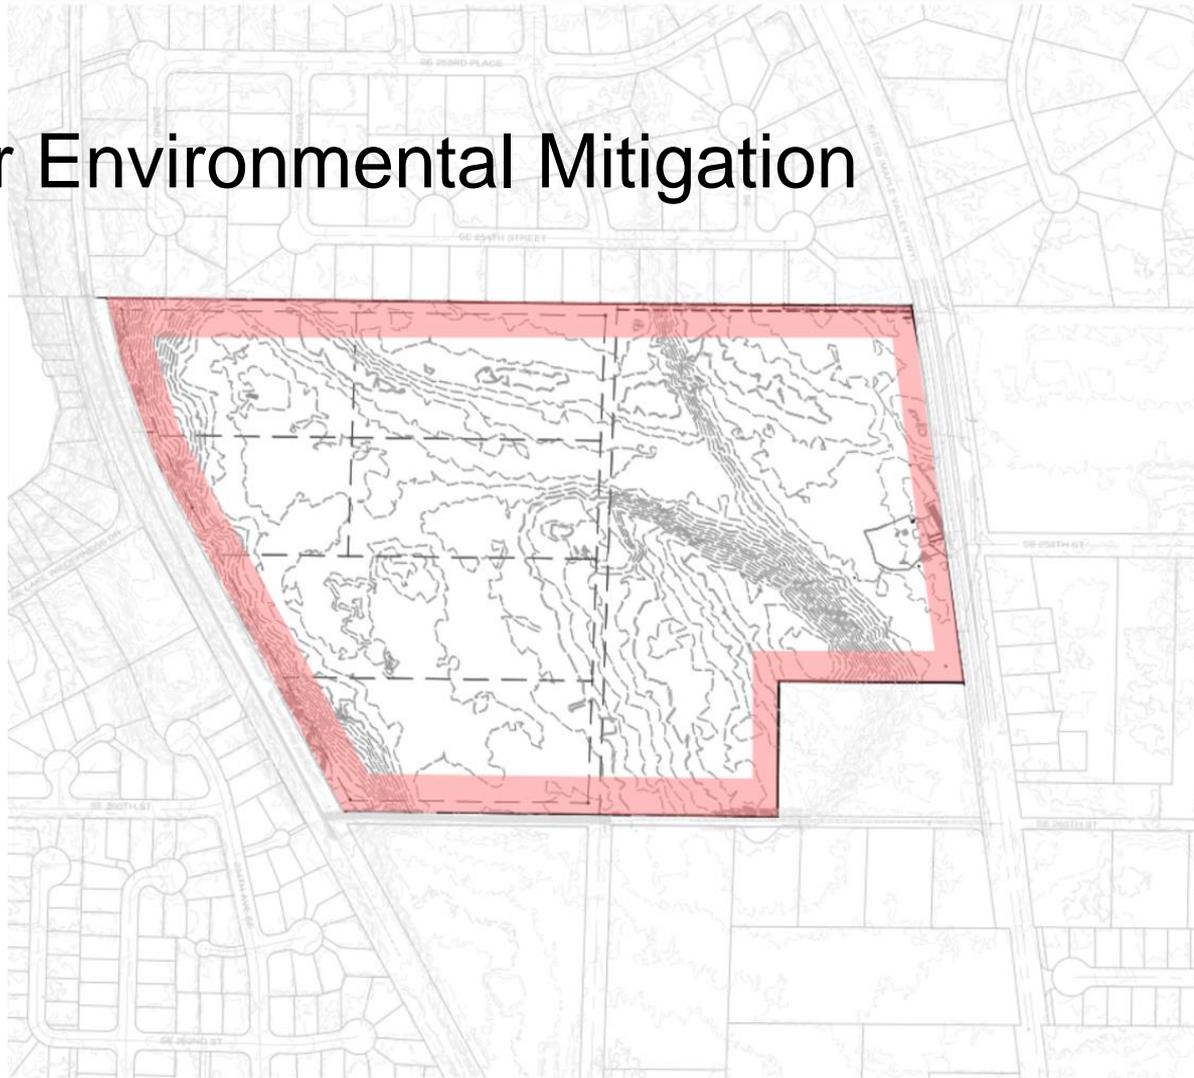
# Proposed Buffer for Environmental Mitigation

Recommendation of 50 ft.

Reasons for buffer zones:

- Protects tree development
- Maintain privacy
- Promotes ecology
- Provide safety
- Mitigate air and sound pollution.
